**Flood Control Project Maintenance  
Levee Inspections**

## Maintenance Issue Types Only, Levee Inspection Report By Mile - Fall 2016

### Reclamation District No. 2092 Dos Rios

Waterway	Bank	Unit Miles	Inspection Start/End	Inspector
Unit No. 01 San Joaquin River	Right	3.71	10/04/2016 10/04/2016	Pavel Kazi

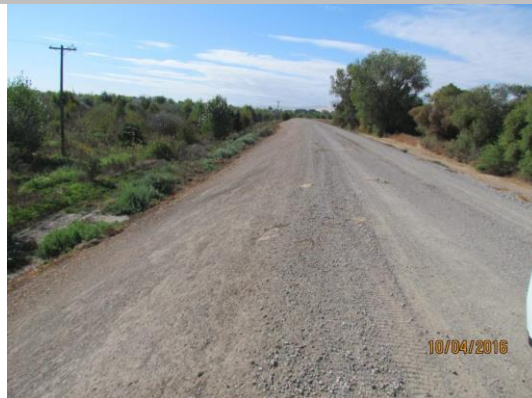
Photo 1 of 1 : FA\_2016\_RD2092\_116\_12\_20161005\_00033.jpg

LM Start	0.40	Rating **	A	Issue No.	12
LM End	0.40	Issue Type +	Ma	Location *	LS
Category	Earthen Levee			GPS Latitude/Longitude	
				Start	End
Item	Vegetation			37.601235 °	37.601235 °
				-121.165117 °	-121.165117 °
DWR ID	DWR_RD2092_01_f_2016_12				
Comment Code					
V1 : Control annual grass and weeds on the levee slopes and easements.					
Inspector Comment					
Acceptable vegetation on the landside of the levee

View of the landside slope of the levee during fall 2016 inspection.

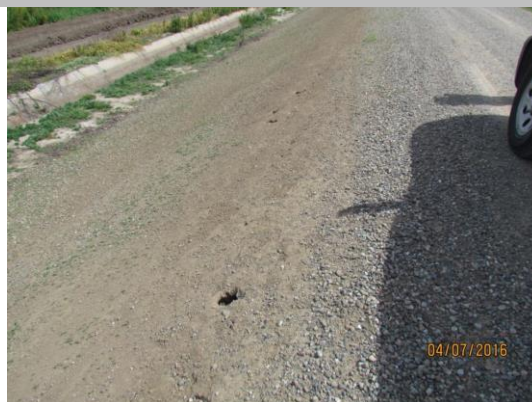
Photo 1 of 1 : FA\_2016\_RD2092\_116\_15\_20160823\_00005.jpg

LM Start	1.21	Rating **	M	Issue No.	15
LM End	1.21	Issue Type +	Ma	Location *	LS
Category	Earthen Levee			GPS Latitude/Longitude	
				Start	End
Item	Animal Control			37.591293 °	37.591293 °
				-121.165434 °	-121.165434 °
DWR ID	DWR_RD2092_01_s_2016_15				
Comment Code					
A3 : No rodents visible, but rodent burrows visible; need to backfill and compact or grout burrows.					
Inspector Comment

View of rodent holes on the landside of the levee.

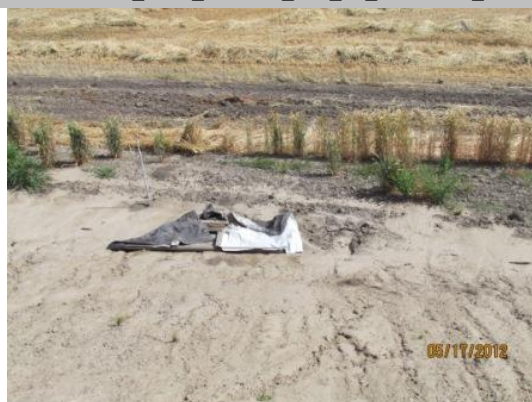
Photo 1 of 2 : FA\_2016\_RD2092\_116\_10\_20160823\_00002.jpg

LM Start	1.32	Rating **	A/W	Issue No.	10
LM End	1.32	Issue Type +	Ma	Location *	LS
Category	Earthen Levee			GPS Latitude/Longitude	
				Start	End
Item	Encroachments			37.590467 °	37.590467 °
				-121.163822 °	-121.163822 °
DWR ID	DWR_RD2092_01_s_2012_10				
Comment Code					
PI : Pipe					
Inspector Comment					
A sand boil appeared on the landside toe of the levee because of an underground pipe leakage. The pipe and boil have been repaired but should be monitored.

During spring inspection 2012, the sand boil was not active but materials were present on the landside toe of the levee. The sand boil occurred due to an underground irrigation pipe leakage. The picture was taken from the crown looking toward the toe of the levee. The area was repaired but should be monitored.

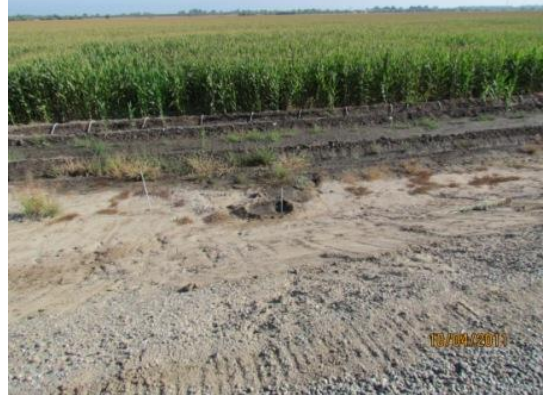
Photo 2 of 2 : FA\_2016\_RD2092\_116\_10\_20160823\_00003.jpg

LM Start	1.32	Rating **	A/W	Issue No.	10 (cont)
LM End	1.32	Issue Type +	Ma	Location *	LS
Category	Earthen Levee			GPS Latitude/Longitude	
				Start	End
Item	Encroachments			37.590467 °	37.590467 °
				-121.163822 °	-121.163822 °
DWR ID	DWR_RD2092_01_s _ 2012_10				
Comment Code					
PI : Pipe					
Inspector Comment					
A sand boil appeared on the landside toe of the levee because of an underground pipe leakage. The pipe and boil have been repaired but should be monitored.

A sand boil was found on the landside of the levee. It was caused by a pipe leak couple of feet below the boil location. LMA was notified to repair it as soon as possible. The picture was taken from the crown looking upstream.

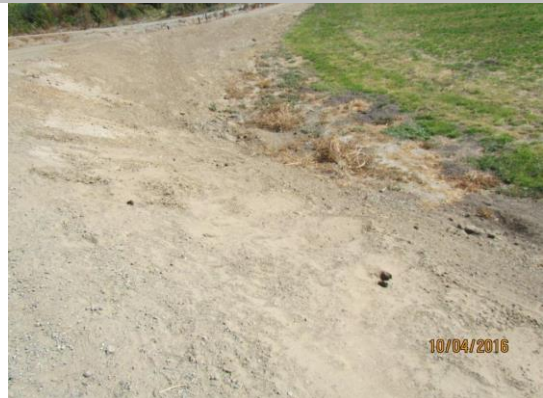
Photo 1 of 1 : FA\_2016\_RD2092\_116\_16\_20161005\_00035.jpg

LM Start	1.56	Rating **	M	Issue No.	16
LM End	1.56	Issue Type +	Ma	Location *	LS
Category	Earthen Levee			GPS Latitude/Longitude	
				Start	End
Item	Animal Control			37.587593 °	37.587593 °
				-121.162431 °	-121.162431 °
DWR ID	DWR_RD2092_01_f_2016_16				
Comment Code					
A3 : No rodents visible, but rodent burrows visible; need to backfill and compact or grout burrows.					
Inspector Comment

View of rodent holes on the landside of the levee looking downstream.

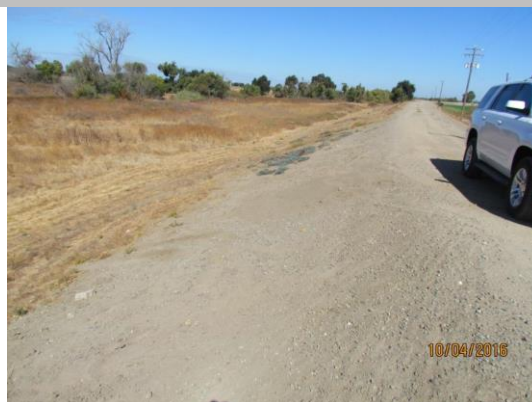
Photo 1 of 2 : FA\_2016\_RD2092\_116\_30\_20161005\_00036.jpg

LM Start	2.73	Rating **	A	Issue No.	30
LM End	2.73	Issue Type +	Ma	Location *	WS
Category	Earthen Levee			GPS Latitude/Longitude	
				Start	End
Item	Animal Control			37.575743 °	37.575743 °
				-121.157237 °	-121.157237 °
DWR ID	DWR_RD2092_01_s_2016_30				
Comment Code					
A3 : No rodents visible, but rodent burrows visible; need to backfill and compact or grout burrows.					
Inspector Comment					
LMA has repaired the rodent holes at this location.

LMA has repaired the rodent holes on the waterside of the levee looking downstream. Fall 2016.

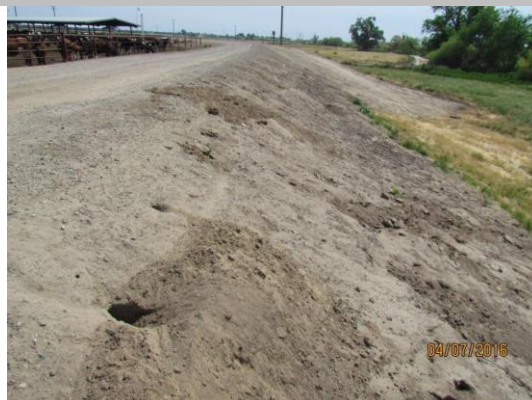
Photo 2 of 2 : FA\_2016\_RD2092\_116\_30\_20160823\_00009.jpg

View of multiple rodent holes on the waterside of the levee looking upstream. Spring 2016.
